## PROJECT REPRESENTATIVE'S DAILY REPORT

Pg. 1  
Report No. 053  
Date: 2014-10-31  
Day: Friday

**Project:** Renovation and Addition to Tewksbury Town Hall

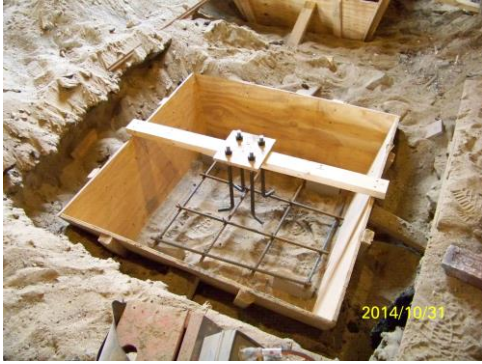
Photo showing the anchors in place.

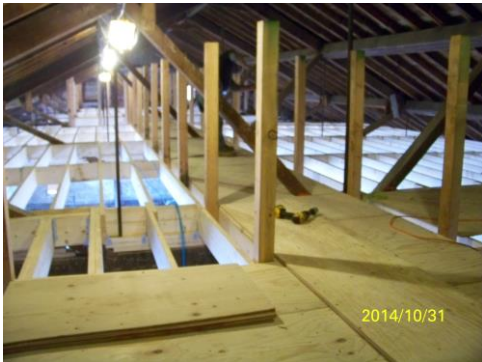
Photo showing catwalk decking being installed.

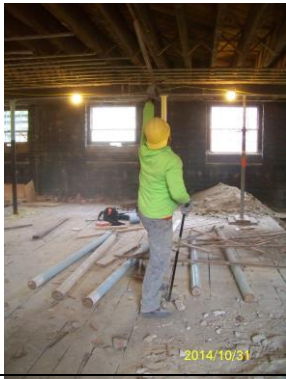
Photo showing demolition of ceiling furring from the basement.

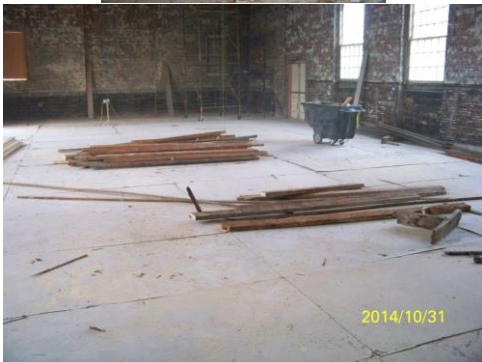
Photo showing pile of ceiling joists removed from the meeting hall.

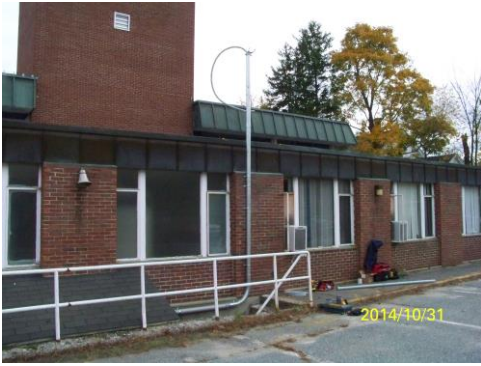
Photo showing temp power conduit in place on the fire station.

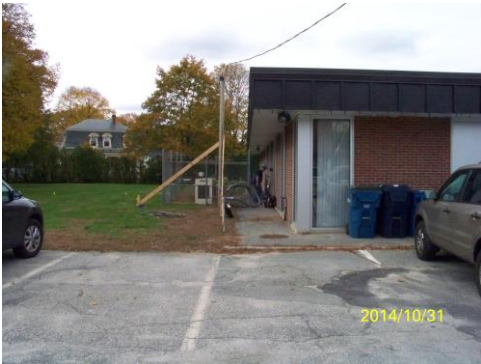
Photo showing temp conduit in place behind the annex.
